# Uniform Mitigation Verification Inspection Form

| Inspection Date: 10/17/2012 | | |
| Owner Name: Jensen Beach Club | | Contact Person: |
| Address: 4444 Ne Ocean Blvd | | Home Phone: (772) 834-1986 |

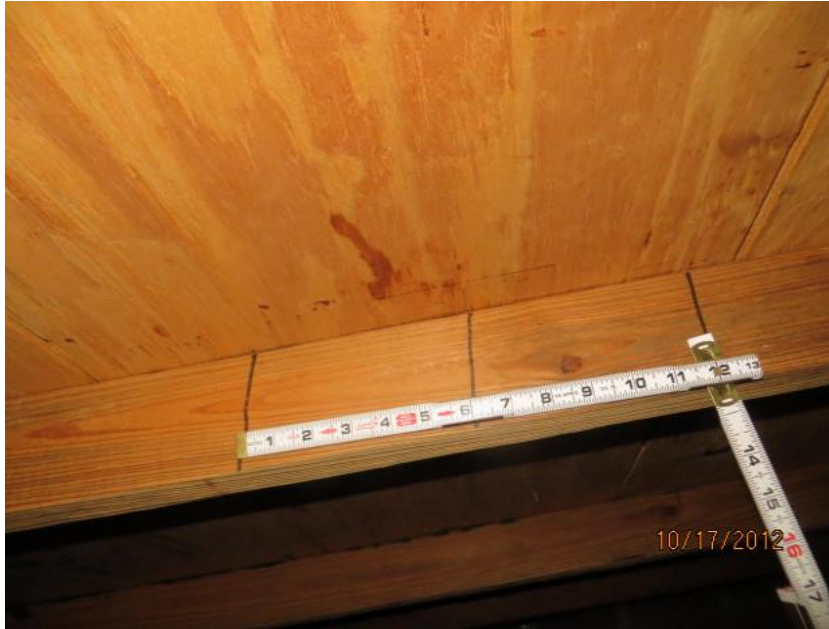
8d Nails Spaced 6" Along the Edge

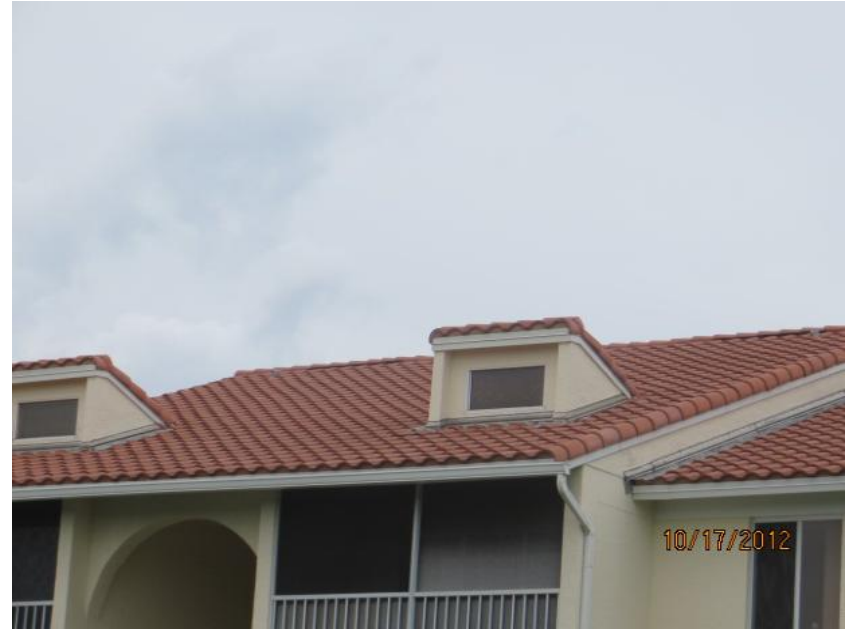
| 2.1 Roof Covering Type: | Permit Application Date | FBC or MDC Product Approval # | Year of Original Installation or Replacement | No Information Provided for Compliance |
|---|---|---|---|---|
| <input checked="" type="checkbox"/> 2. Concrete/Clay Tile | 03 / 07 / 2005 | _____ | _____ | <input type="checkbox"/> |

Concrete/Clay Tile Roof Covering

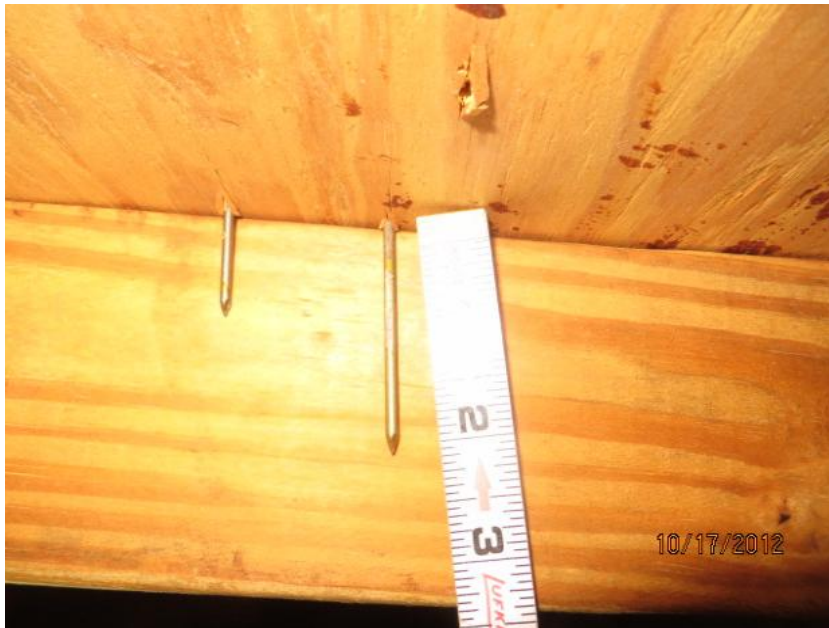
8d Nails

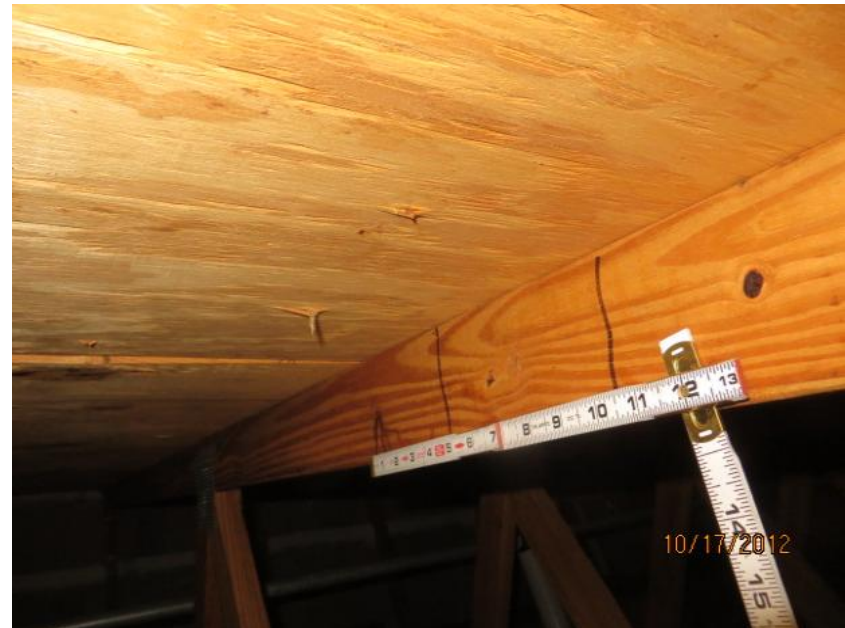
- ☒ C. Plywood/OSB roof sheathing with a minimum thickness of 7/16" inch attached to the roof truss/rafter (spaced a maximum of 24" inches o.c.) by 8d common nails spaced a maximum of 6" inches in the field. -OR- Dimensional lumber/Tongue & Groove decking with a minimum of 2 nails per board (or 1 nail per board if each board is equal to or less than 6 inches in width). -OR-

8d Nails Spaced 6" in the Field

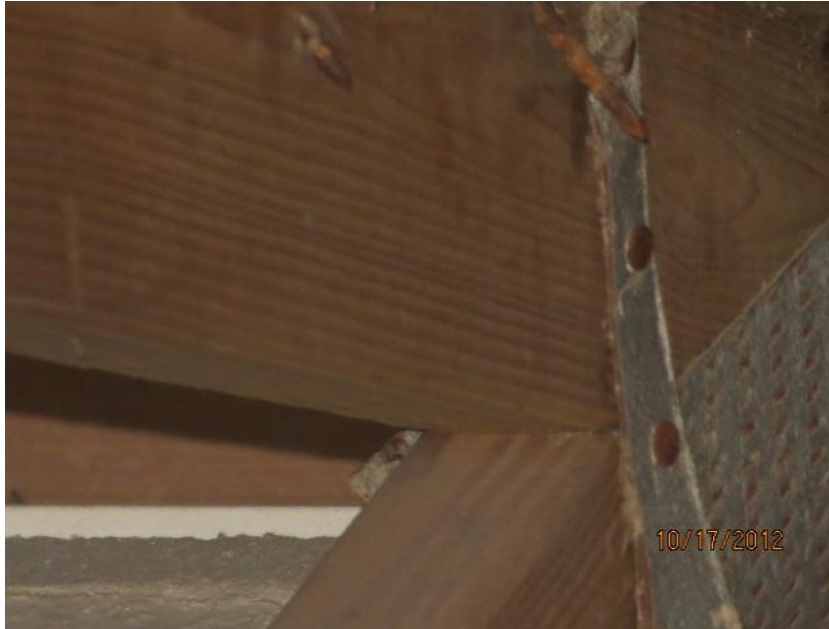
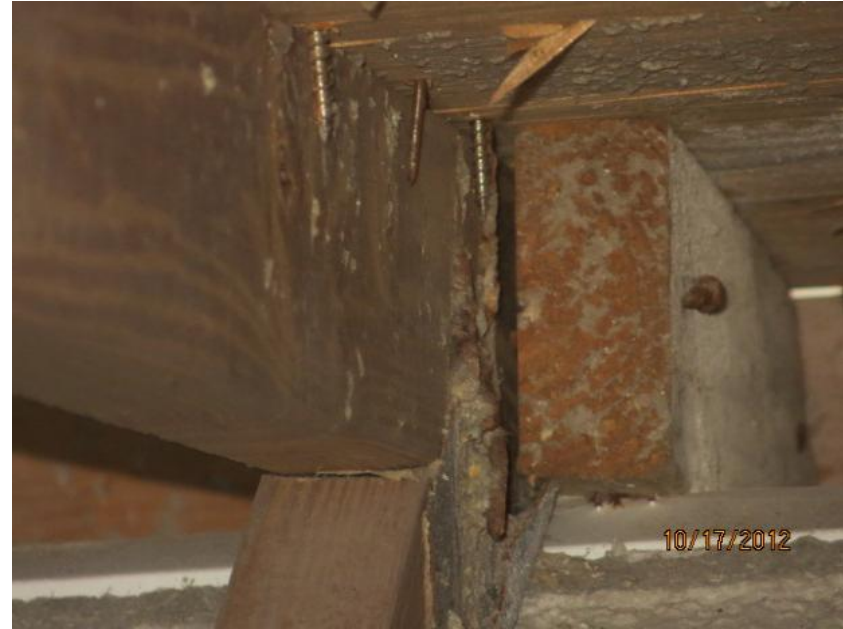
- ☒ B. Clips
  - ☒ Metal connectors that do not wrap over the top of the truss/rafter, **or**
  - ☐ Metal connectors with a minimum of 1 strap that wraps over the top of the truss/rafter and does not meet the nail position requirements of C or D, but is secured with a minimum of 3 nails.

Clip with 3 nails on the front side and 0 nails on the opposing side

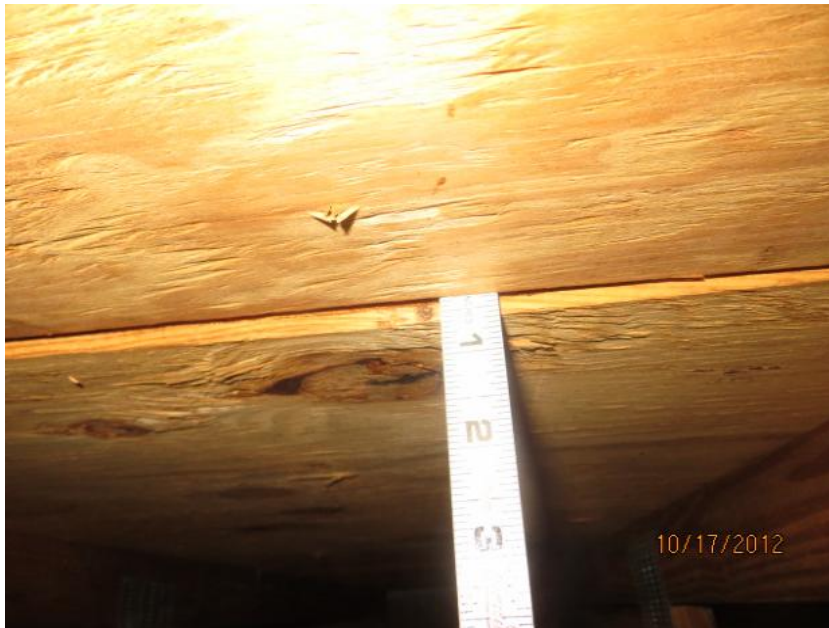
5/8" Deck Thickness Confirmed
